# STRUCTURAL INSIGHTS IN PLANNING AND INFRASTRUCTURE LEADERSHIP (SIPIL)

Vol. 1 No. 1 (2026) 42 – 55 | ISSN: XXXX - XXXX (Media Online)

## Geotextile Integration in Revetment and Gabion Construction for Riverbank Landslide Control: A Field Study in Batang Suliti

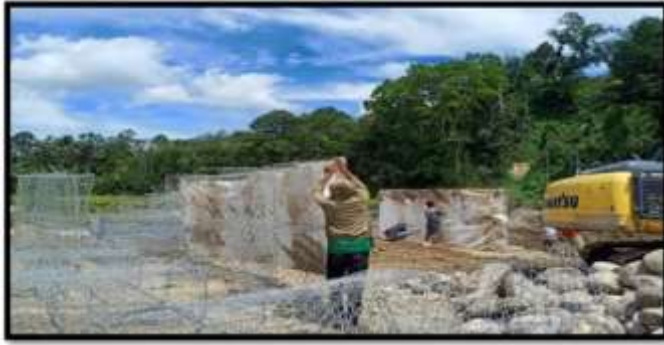
Figure 1. Gabion installation phase showing geotextile underneath the baskets

Following geotextile placement, wire-mesh gabions were assembled and filled with angular stone (150–300 mm diameter). The gabion baskets were stacked in a stepped pattern, forming a flexible yet robust retaining structure. On top of the gabions, a revetment of hand-placed stones was installed, providing an outer protective face against direct water impact. Drain holes were added at intervals to prevent hydrostatic buildup.

Geotextile installation was conducted before any gabion or revetment elements were placed. A non-woven polyester geotextile layer was rolled and laid directly on the compacted subgrade. Overlaps of 30–50 cm were maintained between rolls to prevent soil piping along the joints. The geotextile was temporarily anchored using iron pins and edge trenching, then overlaid with a 10 cm bedding layer of medium sand to facilitate drainage.
